**OUR LADY OF PEACE & BLESSED ROBERT DIBDALE**

**CHURCH LANE  
SHOTTERY  
STRATFORD-UPON-AVON  
WARWICKSHIRE  
CV37 9HQ**

**QUINQUENNIAL INSPECTION 2025**

**February 2025**

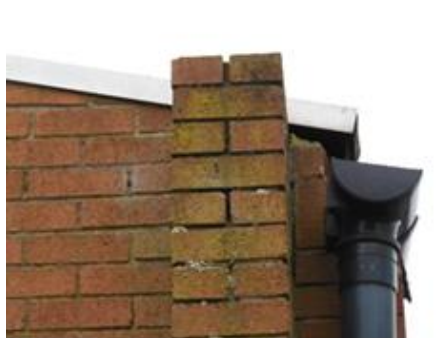
- a) The capping to the north west brick pier is missing and a replacement should be fitted

There are a number of open mortar joints to the upper courses of the pier and these require repointing.

The upper brickwork to the pier appears to have moved and is out of alignment with the base courses, just above ground level

It is recommended that this movement is inspected by a structural engineer.

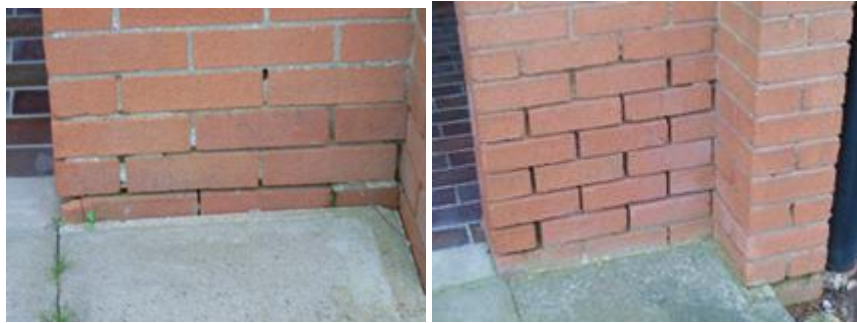
- d) Further open mortar joints are evident to the low level brickwork to the north and south of the lobby entrance arch

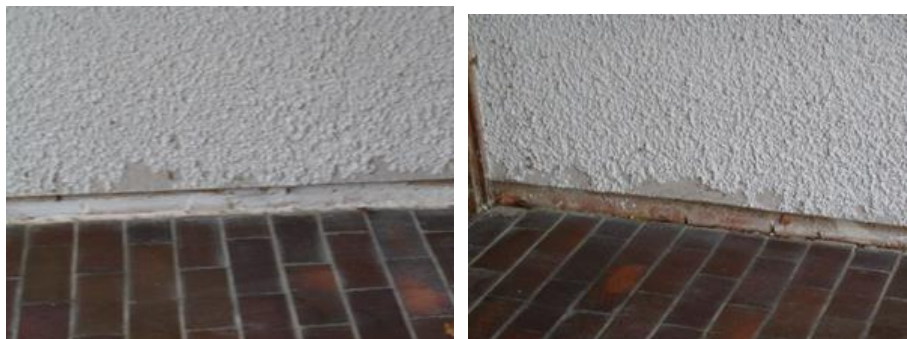
- e) The lower sections of render to the north and south walls of the lobby are damaged and require repair.

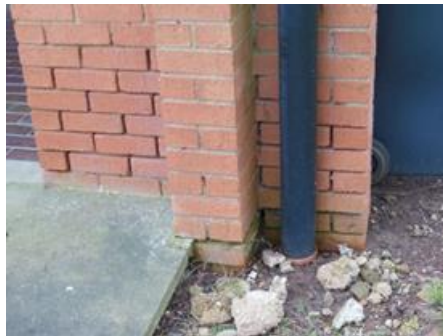
- f) The south west facing brick pier has a number of open mortar joints and the upper section of the pier is out of alignment with the lower brick courses (just above ground level). It is recommended that a structural engineer view and comment on the cause of this defect.

The upper section of the pier does not have any lead capping.

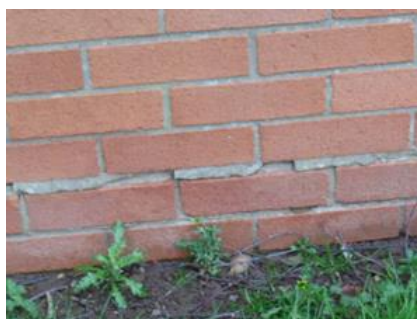
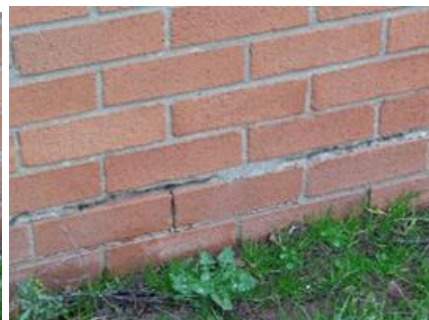
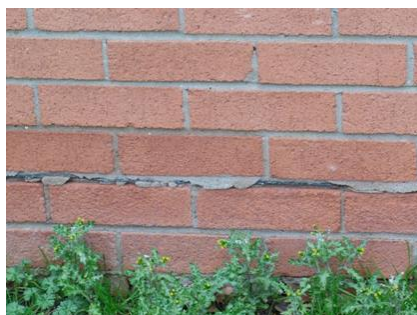
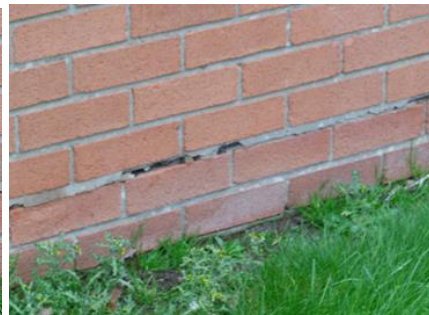
- g) Much of the mortar pointing to the dpc around the base of the building is cracked and has fallen out.

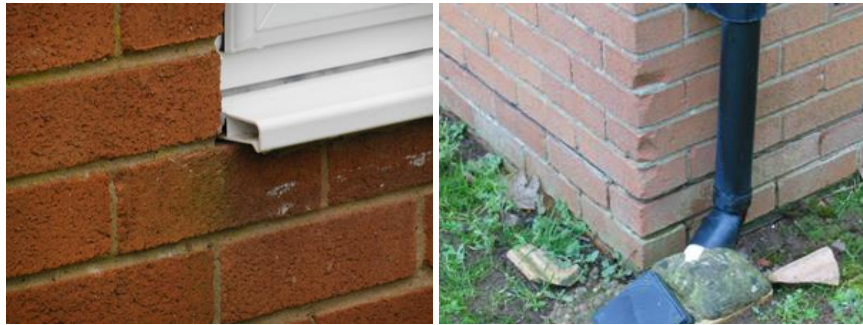
- h) There are open mortar joints to the facing brickwork at the south east quoin. Some pieces of brickwork are chipped and pieces have broken away.

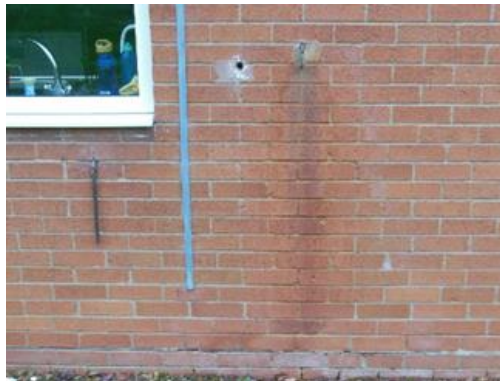
- i) The boiler overflow pipe is continually dripping and staining the facing brickwork on the east wall of the kitchen

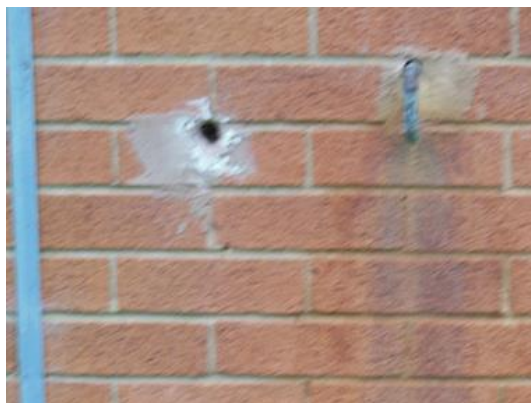
The old redundant services hole in the brickwork adjacent to the overflow pipe should be filled with mortar.

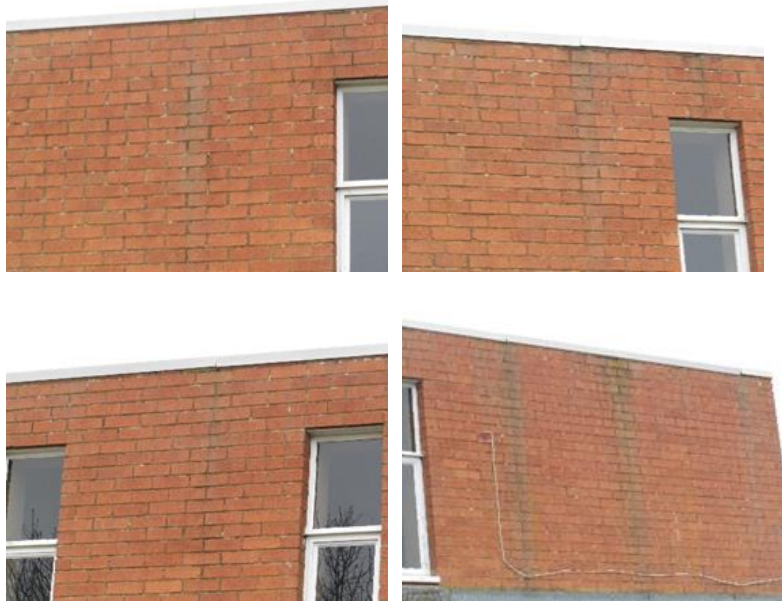
- j) The Clerestery facing brickwork is stained due to the joints of the aluminium roof/brickwork cappings not being sealed

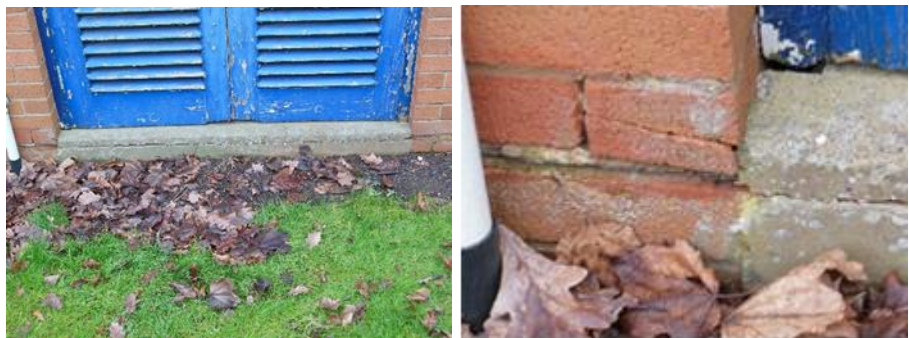
- k) The brickwork to the lower left side of the left door of the boiler house is cracked and should be replaced

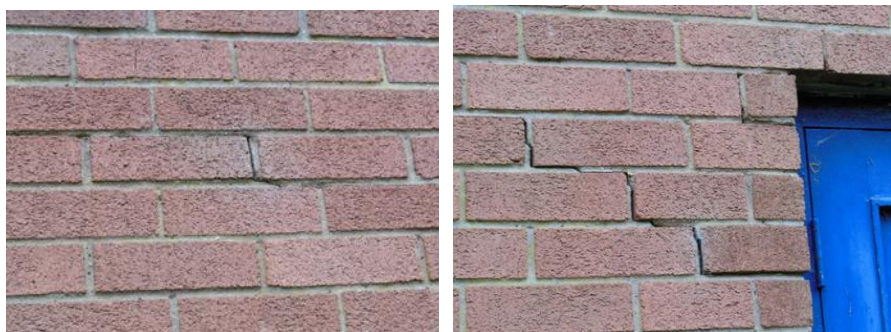
- l) There are significant movement cracks through the mortar joints of the high level facing brickwork to the right hand side of the boiler horse door and the high level facing brickwork to the left hand side of the garden store door

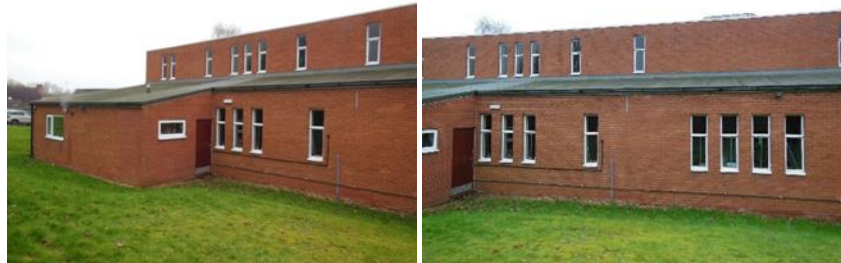
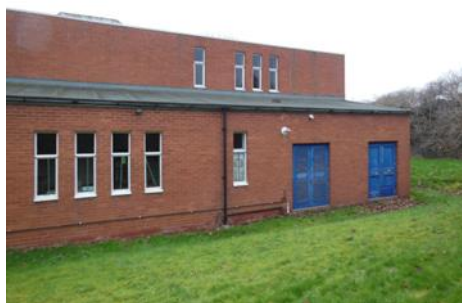
As reported the mineral felt coverings to the mono pitched roofs appear to be close to the end of their useful lives and there is evidence of poor detailing at important junctions

The roof covering will possibly cause some problems in the next 5-10 years.

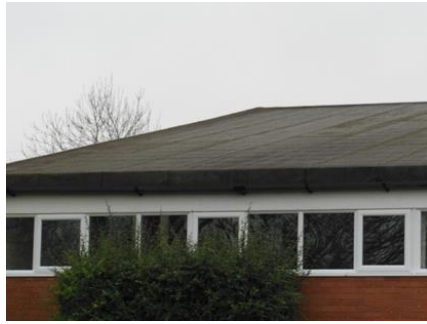
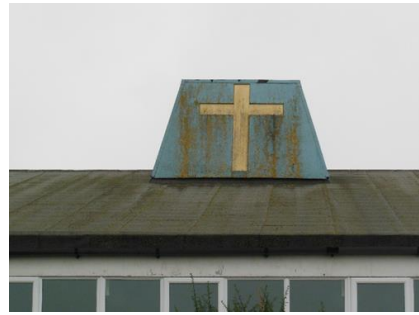
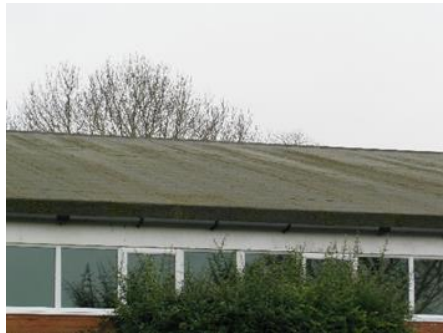
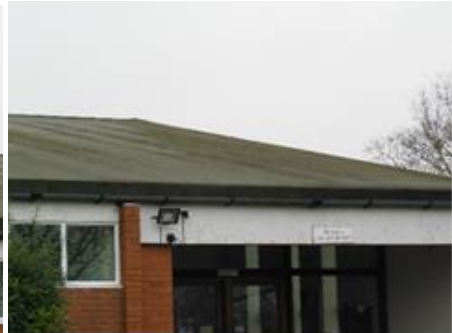
- a) The felt covering to the west roof slope has some lichen/moss growth and it is looking quite uneven.

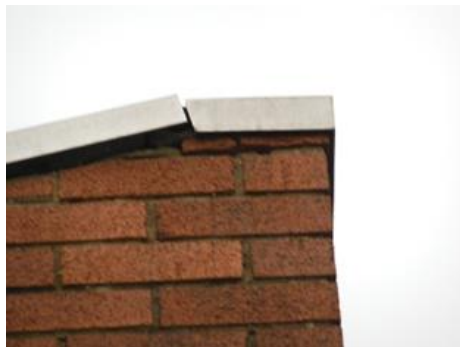
- b) The aluminium capping at the south east quoin of the Clerestory requires refixing and the junction of the capping pieces sealed. The brickwork mortar joints require repointing.

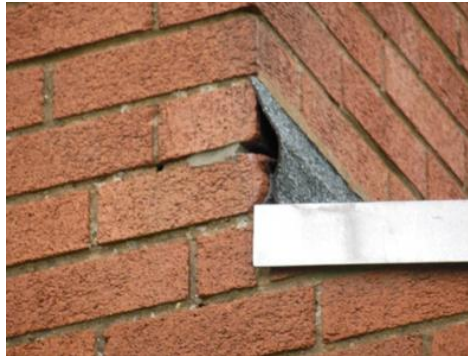
- c) As highlighted in the last report the south end of the felt upstand flashing to the east elevation of the Clerestory (above the kitchen roof) is open to the elements. This is not good and a careful watertight repair is required

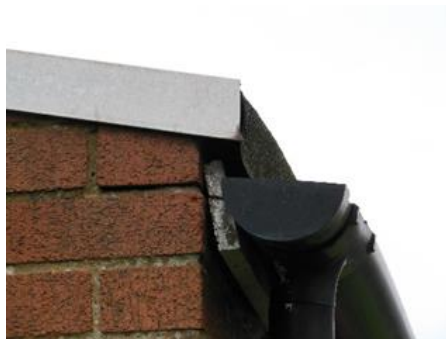
- d) The detail at the southern end of the eaves fascia to the kitchen is not weatherproof and a careful watertight repair is required

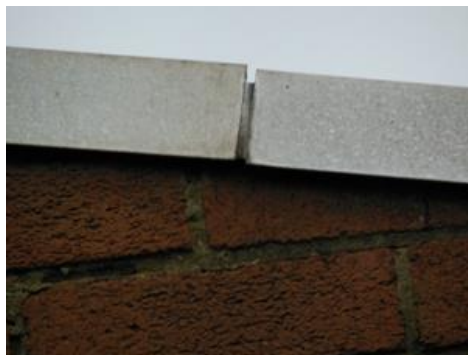
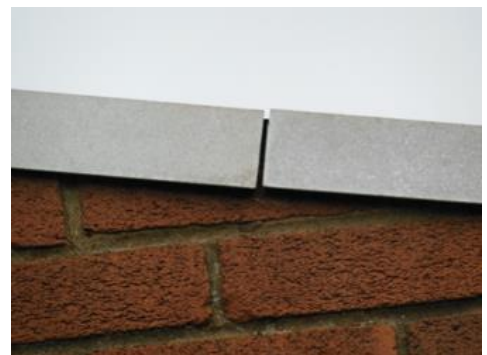
- e) The joints of the aluminium cappings to the felt roofs should be sealed (with a two part polysulphide sealant).

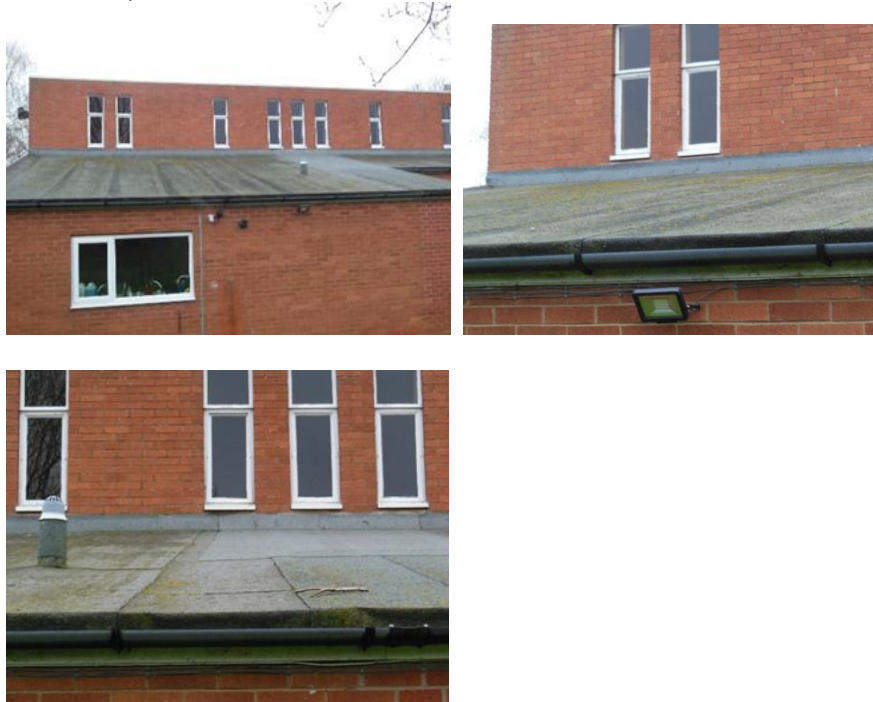
- f) The felt covering to the east roof slope is uneven and is covered with lichen/moss growth. Areas of the roof appear to have received patch repairs

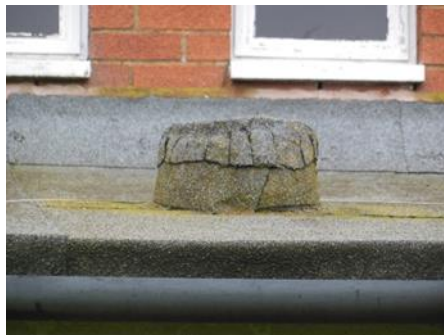
- g) The bituminised felt covering to the redundant boiler flue appears to be nearing the end of its useful life

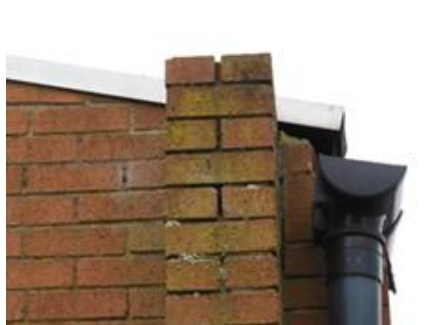
- h) As previously reported there is a large void at the junction of the west eaves and north verge. This requires a watertight repair.

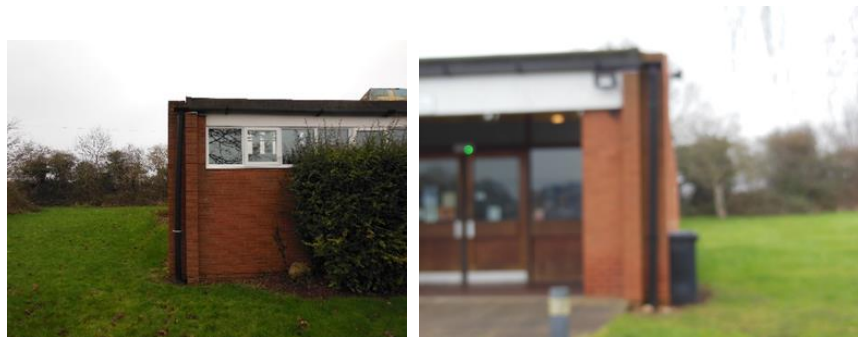
- a) The downpipes at the north and south ends of the west elevation are out of alignment and should be refitted.

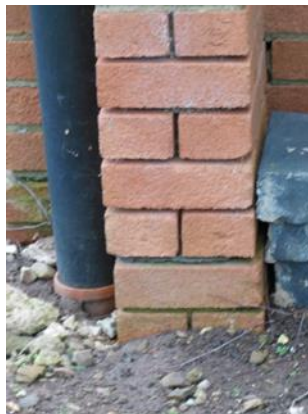
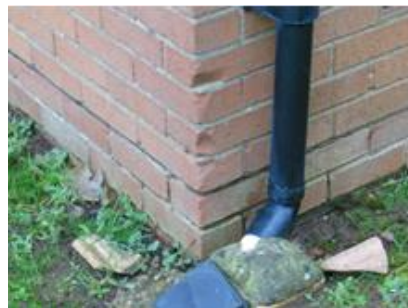
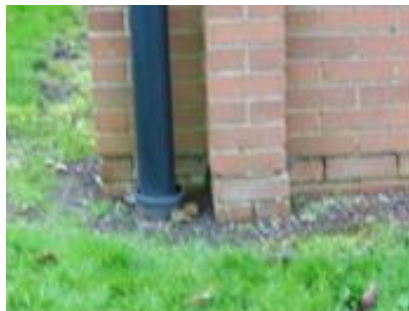
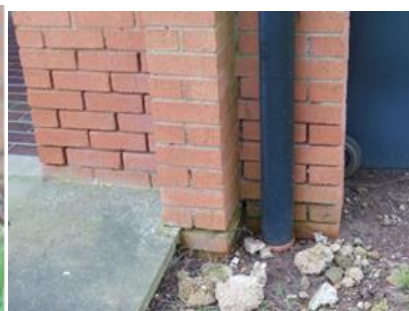
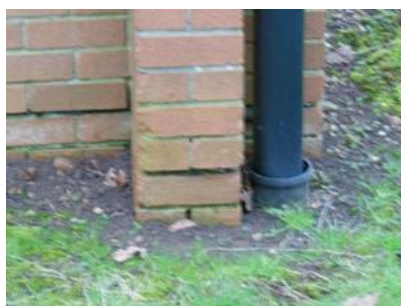
- d) The rainwater downpipes fit directly into the underground drainage, i.e. there is no ground gully that could be cleared of debris. This is a rather unfortunate detail, as any blockages within the pipe can only be pushed further down the underground drain.

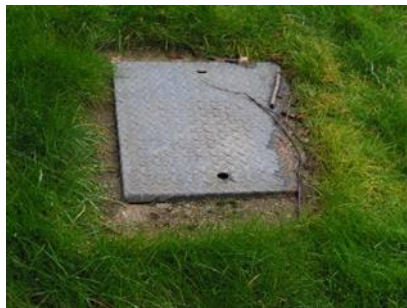
- a) One of the manhole covers to the south side of the building is loose and requires to be refitted

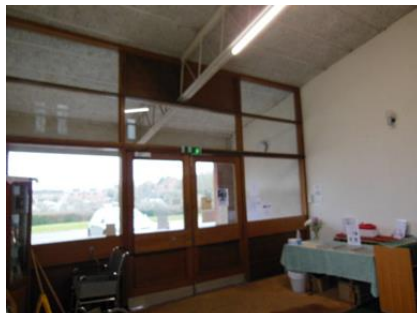
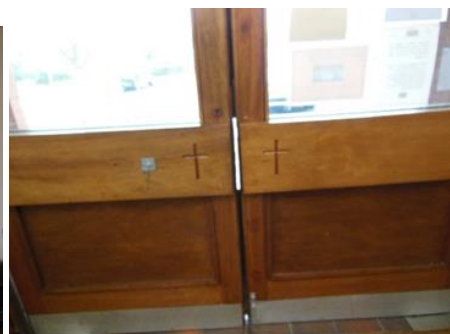
- a) Daylight can be seen through the meeting styles of the main entrance doors into the Narthex

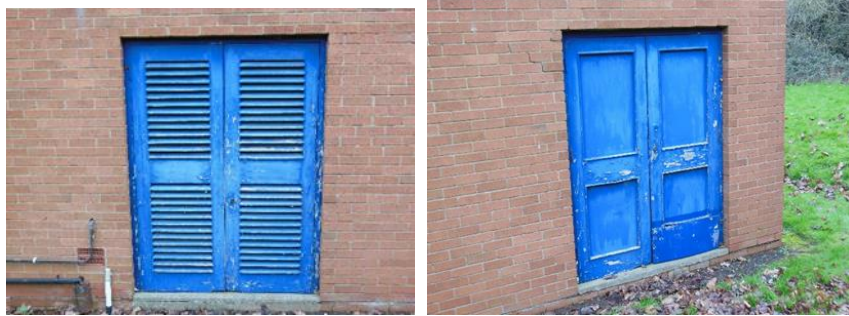
- b) The external timber boiler house and store room doors are in a poor condition and require major joinery repairs. There are gaps at the meeting style

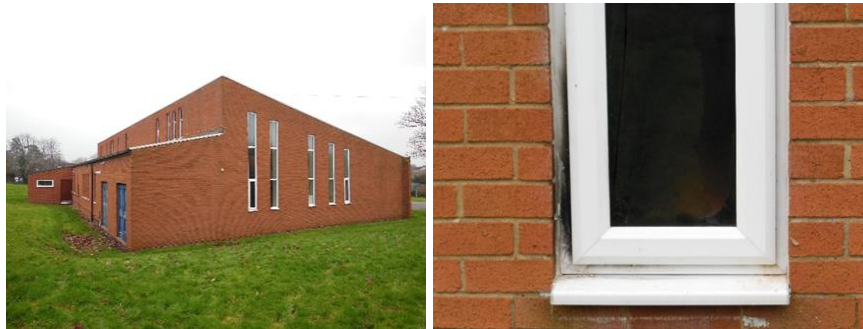
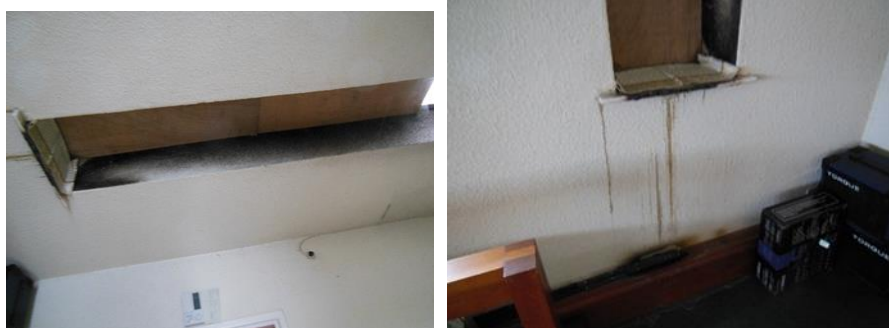
- a) The window at the eastern end of the north elevation has received some fire damage.

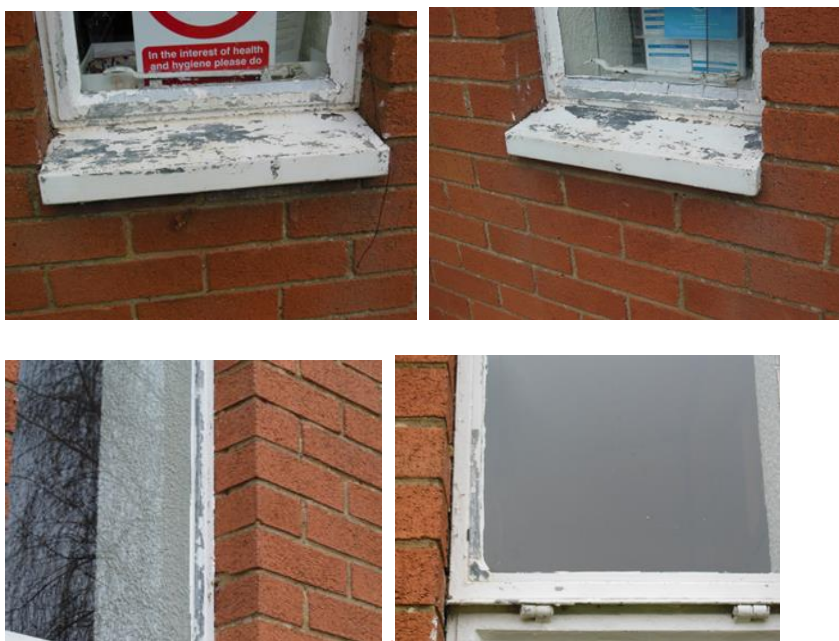
- c) The metal framed single glazed windows require careful redecoration

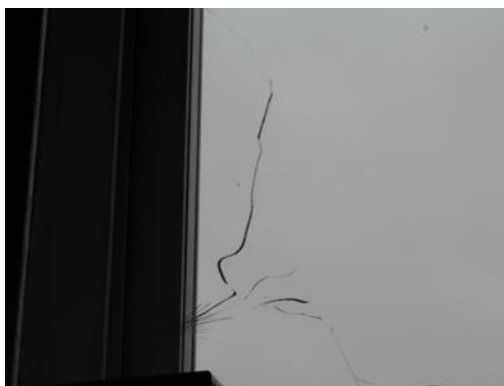
- d) One of the glass window panes in the Church (west elevation – central bay) is cracked. This was recorded in 2020

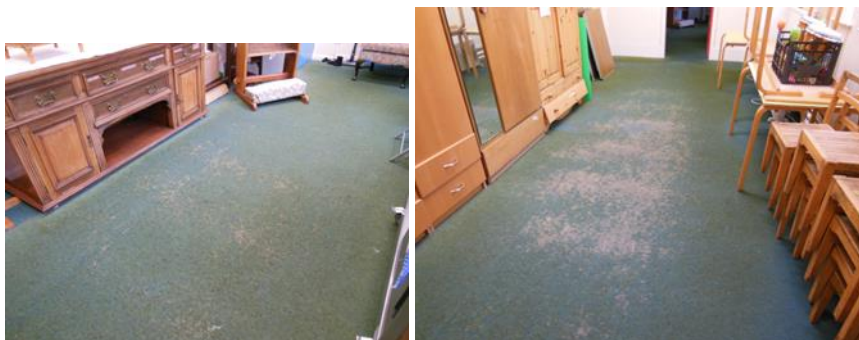
- a) The carpets to the floors of the sacristy, children's liturgy room, community meeting room, church are all worn and stained. They should be upgraded when suitable funds permit

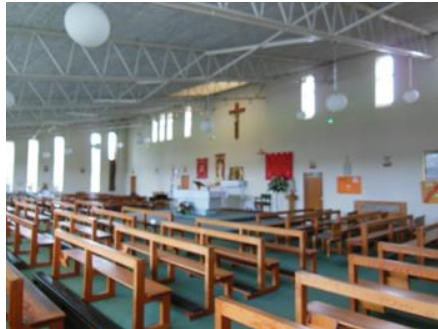
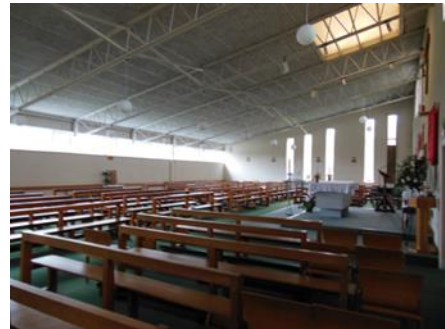
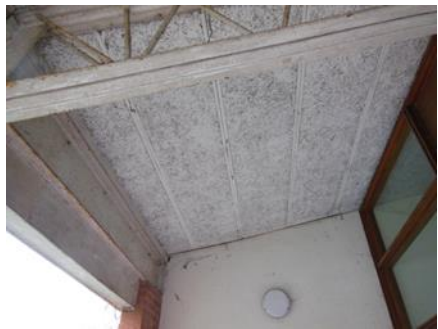
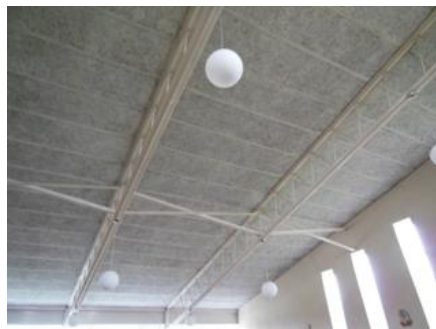
- a) The lobby, narthex, community meeting room and church do not have a finished ceiling. The underside of the structural roof (Strammit board) decking is painted. These rooms do not have any thermal insulation (i.e. in the ceiling, wall nor under the floor slab).

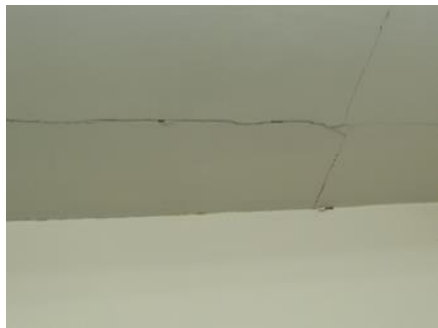
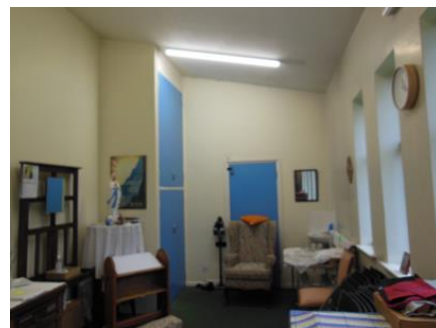
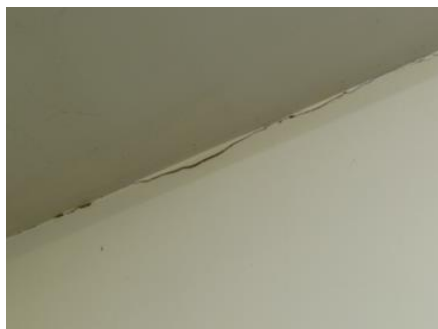
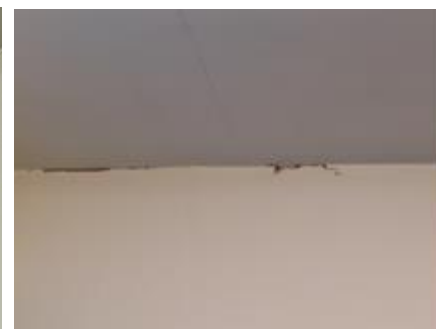
- b) The plaster-boarded and skimmed ceilings to the sacristy, children's liturgy room, toilets, corridor and kitchen show signs of some shrinkage cracks. Outlines of the plasterboard sheets are visible. Further cracking is evident at the junctions of the ceilings and the walls.

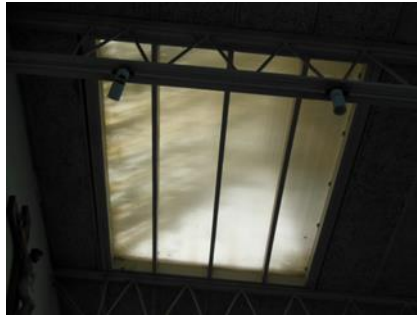
- c) The plastic sheet to the underside of the rooflight above the alter has discoloured. It appears to be covered in dust and flies on the rooflight side.

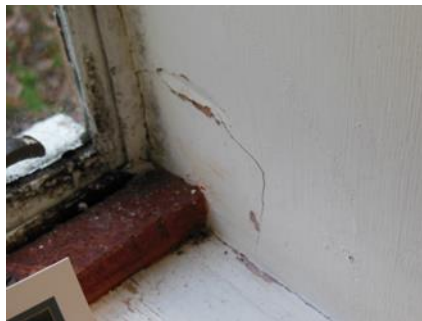
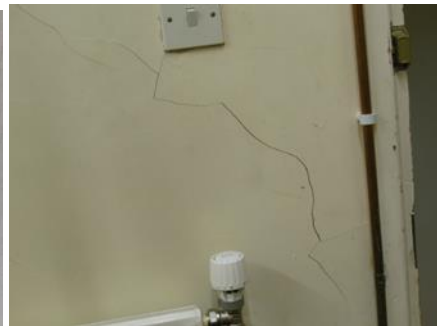
- a) Throughout the building there are visible cracks in the plaster. These are through structural movement and settlement. They are particularly poor in the sacristy and children's liturgy room.

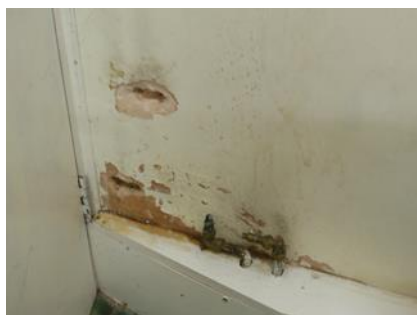
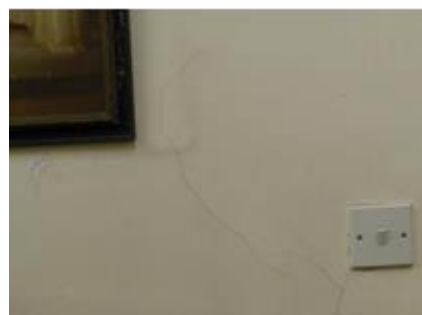
- b) The plaster behind the door into the children's liturgy room (from the courtyard) is in poor condition.

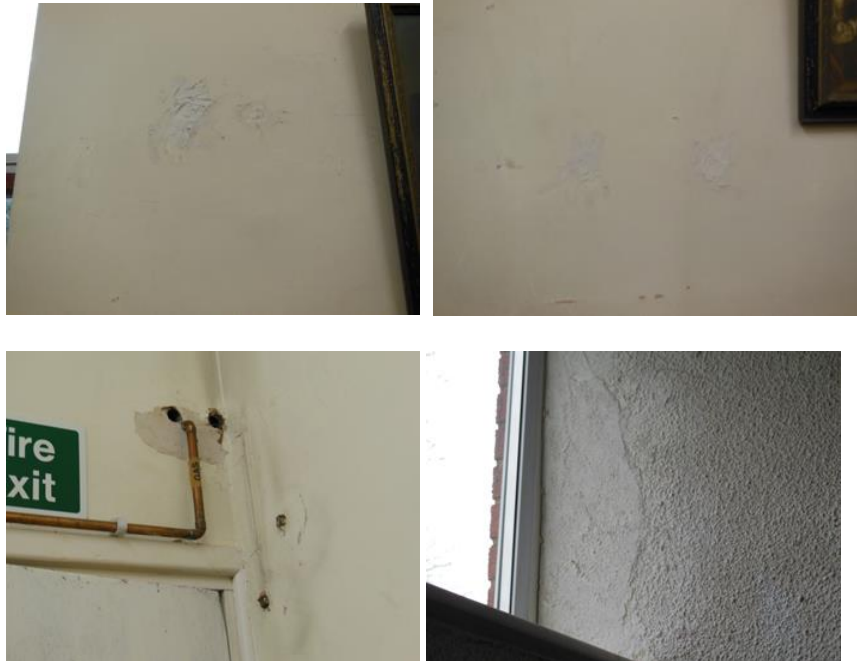
- c) Throughout the building the standard of plaster repairs are substandard

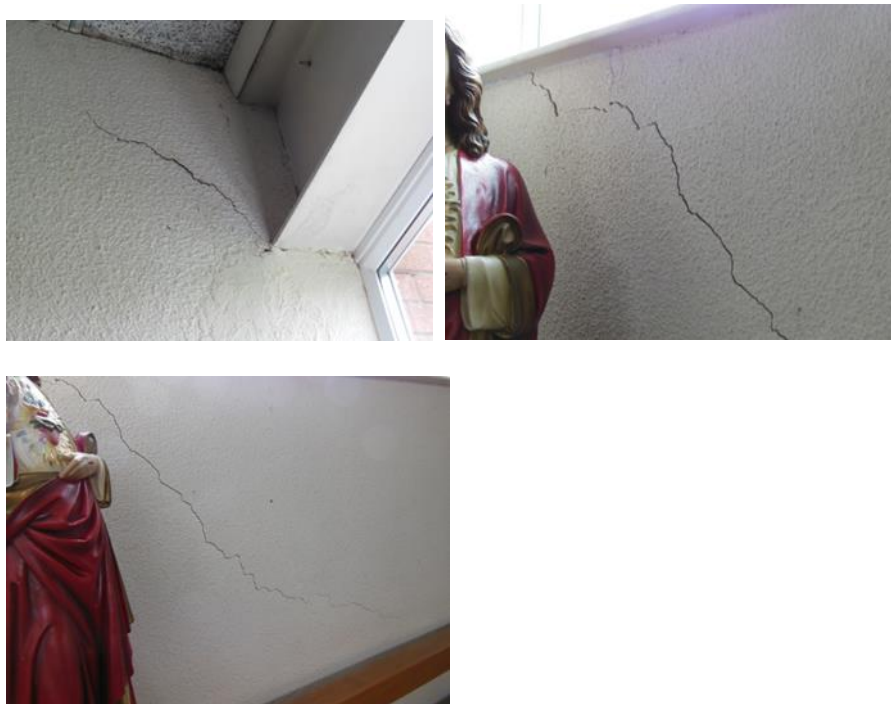
- d) The major movement crack in the south west corner of the church reported in 2020 is still very much evident and might be slightly worse.

It is recommended that a structural engineer visit and inspect this damage.

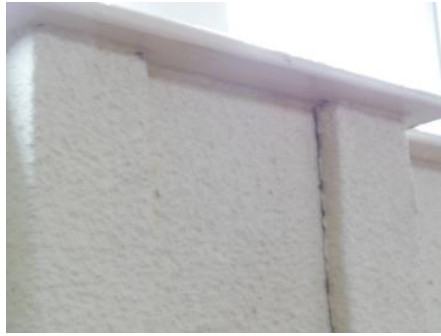
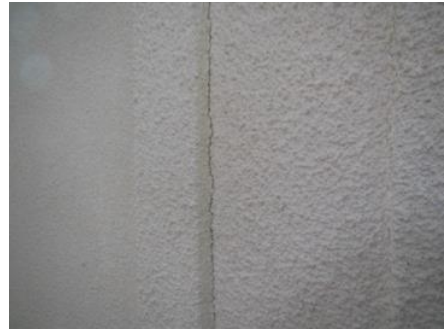
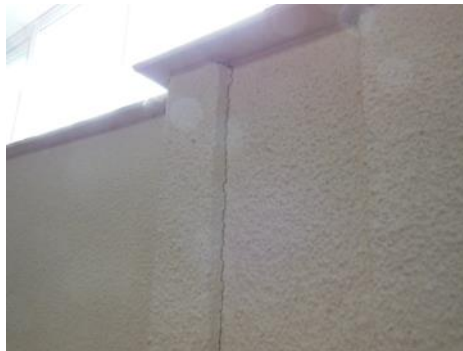
- e) Minor shrinkage cracks are evident around the render cladding panels in the west wall

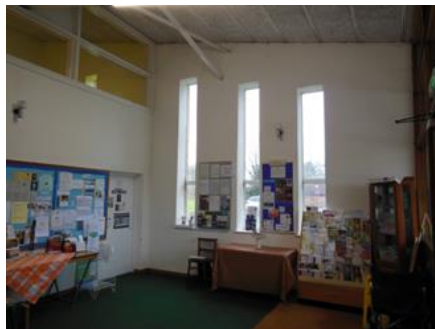
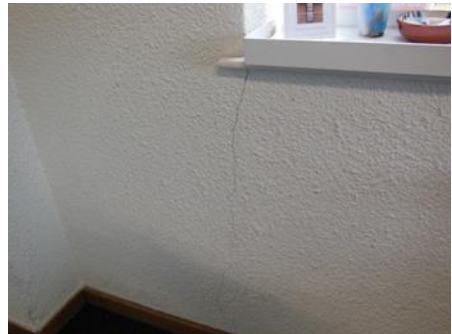
- f) There is a crack in the wall below the cill of the south east window of the Narthex

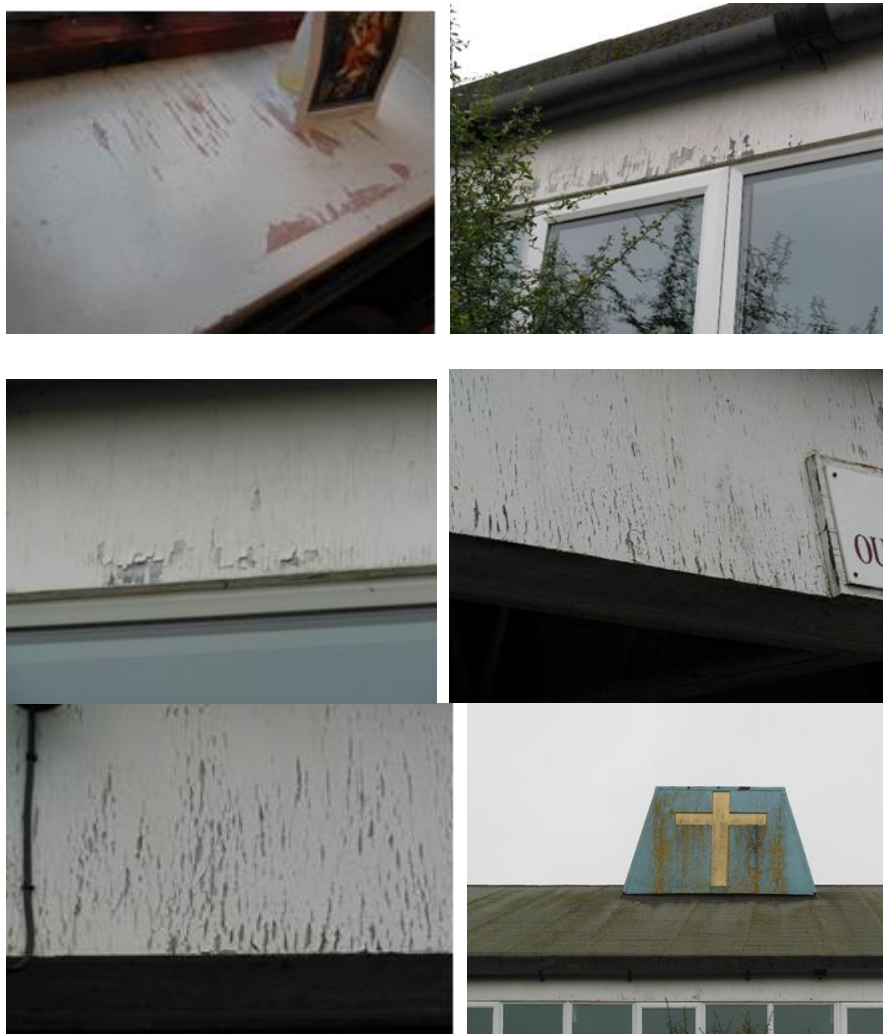
The standard of decoration both internally and externally is not good. Many items are overdue for redecoration.

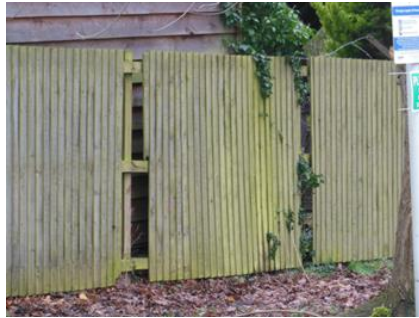
- a) As recorded in 2020 some of the feather edged boarding to a section of the southern boundary fence has been damaged and pieces are missing. Repairs are required

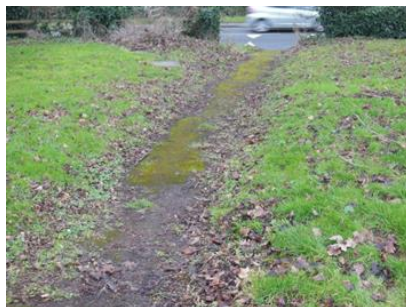
- c) The pathway leading from the car park to Shottery Lane is covered in moss growth.
