**OUR LADY OF PEACE & BLESSED ROBERT DIBDALE**

**CHURCH LANE  
SHOTTERY  
STRATFORD-UPON-AVON  
WARWICKSHIRE  
CV37 9HQ**

**QUINQUENNIAL INSPECTION 2025**

**February 2025**

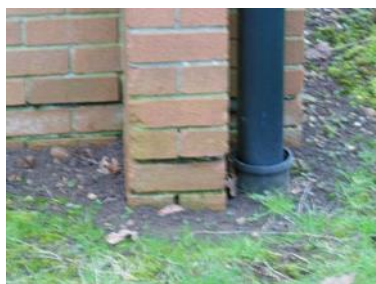
There are a number of open mortar joints to the upper courses of the pier and these require repointing.

The upper brickwork to the pier appears to have moved and is out of alignment with the base courses, just above ground level

It is recommended that this movement is inspected by a structural engineer.

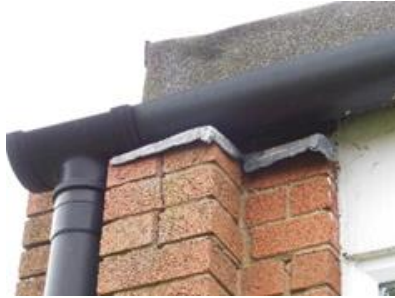
- b) The lead capping to the top of the west brick pier appears to have been tampered with and requires to be redressed. The upper brickwork courses are cracked. This is probably due to some structural movement.

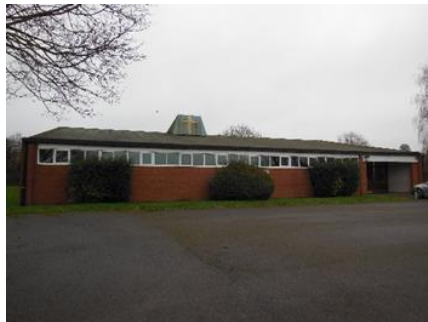
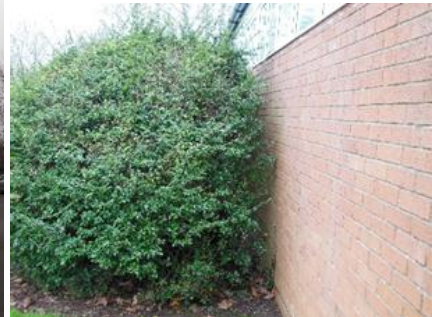
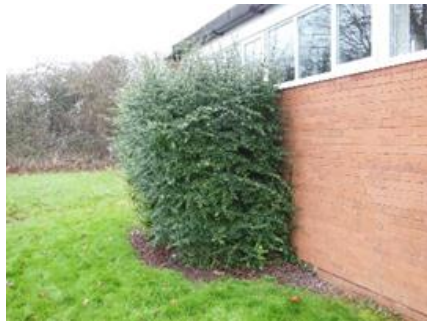
- c) The bushes along the west elevation are growing too close to the facing brickwork and should be carefully trimmed back.

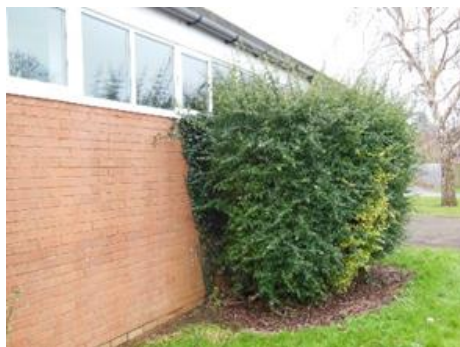
The ivy growth on the wall behind the south western bush should be carefully removed

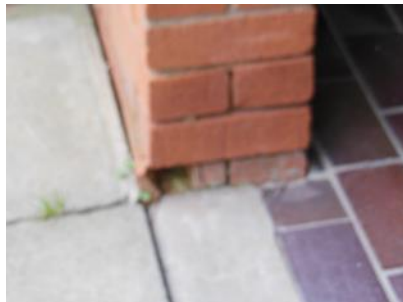
One of the facing bricks to the return of the north side of the lobby arch is cracked and requires replacement

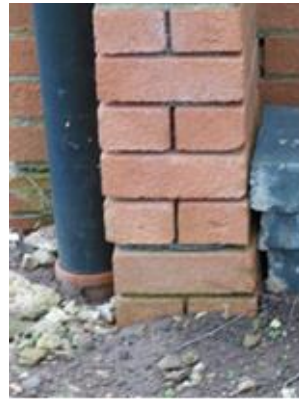
- f) The south west facing brick pier has a number of open mortar joints and the upper section of the pier is out of alignment with the lower brick courses (just above ground level). It is recommended that a structural engineer view and comment on the cause of this defect.

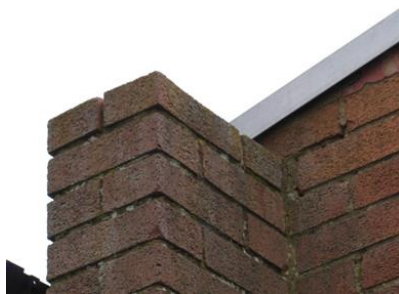
The upper section of the pier does not have any lead capping.

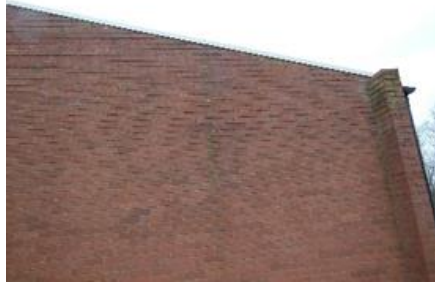
- m) There are a few open mortar joints to the facing brickwork of the north elevation at its western end. There is further water staining to the brickwork due to the unsealed aluminium cappings

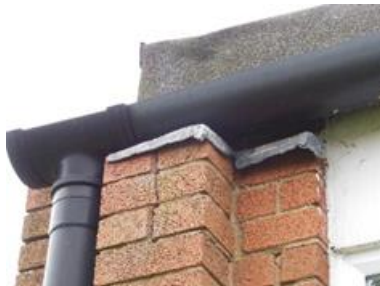
The felt along the eaves is distorted in certain areas

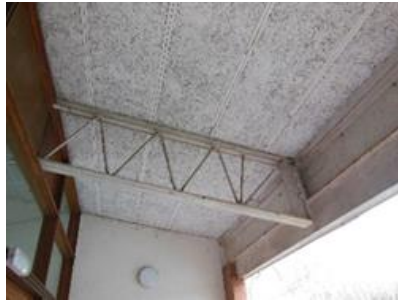
- i) The steel beams passing through the top of the screen to the main entrance doors promote a “cold bridge” and is an extremely poor detail

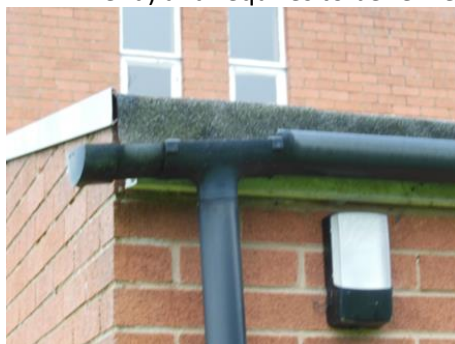
- b) A section of the east gutter to the kitchen roof has a backfall (southern end) and requires to be refixed.

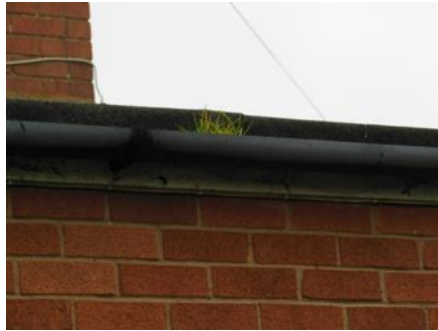
- c) The weeds growing in the east gutter above the store cupboard (northern end) require removal

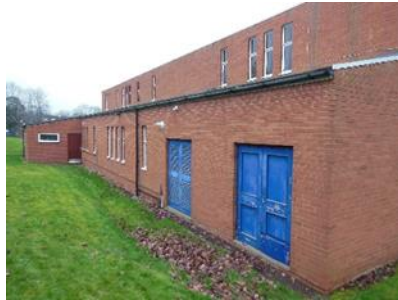
- e) The main rainwater gutter to the east roof slope has only one downpipe to take the rainwater away. It is recommended that another downpipe be added.

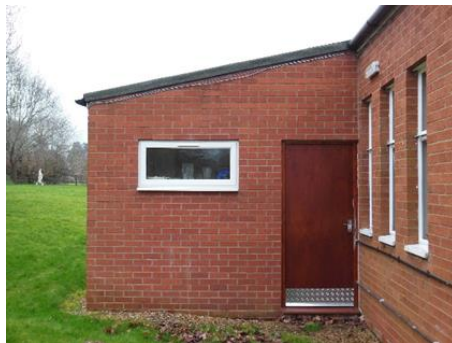
- c) The external door from the kitchen lobby area is called a “Fire Door” but it is not outward opening and it does not have a push bar. The width of the door to allow wheelchair access/egress is also questionable. There is also a considerable drop to the external ground level from the internal finished floor level

It is likely that under Building Regulations this door could not be designated a Fire Exit Door.

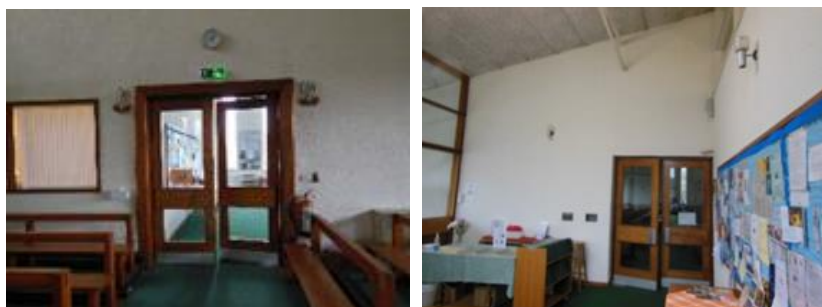
- d) The internal doors to the kitchen, sacristy, children’s liturgy room, boiler and store rooms are not fire rated and the doors and door frames should be upgraded to comply with current fire regulations.
- e) The doors between the Narthex and Church do not close and should be fire resistant (including the door frames).

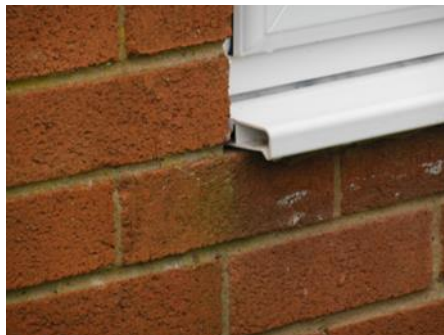
- b) Some of the window cills of the UPVC plastic windows are uncapped

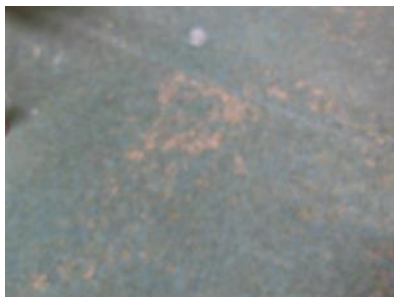
- a) The carpets to the floors of the sacristy, children's liturgy room, community meeting room, church are all worn and stained. They should be upgraded when suitable funds permit

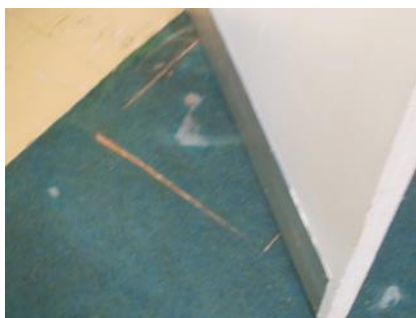
The carpet into the children's reading room (from the corridor) is uneven and the door requires easing in order that it may open freely.

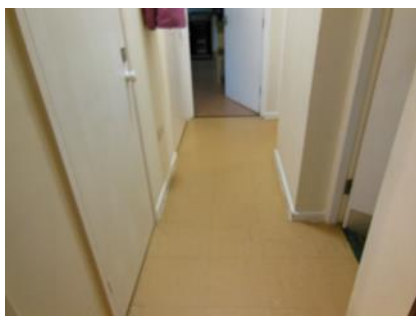
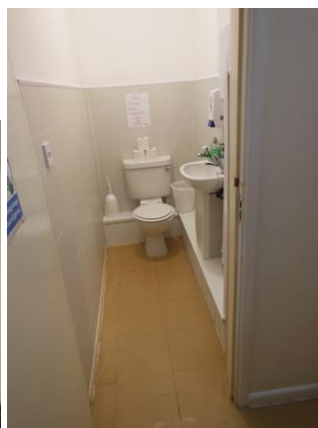
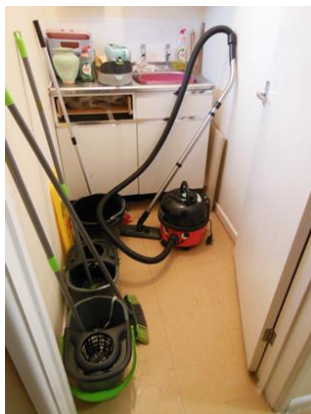
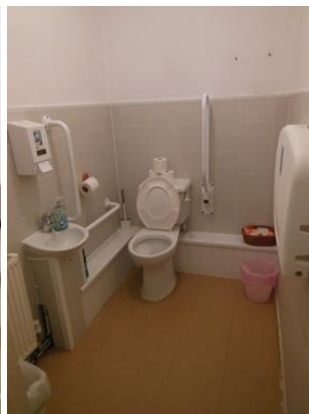
- b) As previously recorded the thermoplastic floor tiles to the rear lobby, flower room and toilets are likely to have some asbestos fibre content.

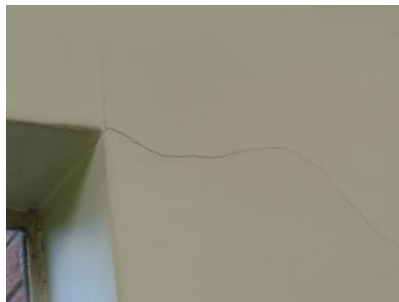
- a) Throughout the building there are visible cracks in the plaster. These are through structural movement and settlement. They are particularly poor in the sacristy and children's liturgy room.

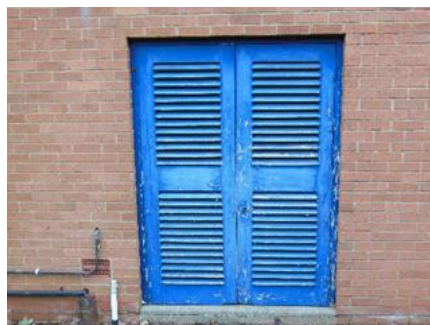
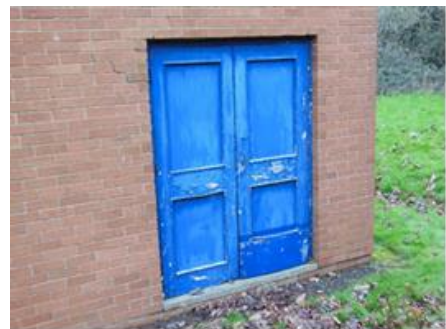
The standard of decoration both internally and externally is not good. Many items are overdue for redecoration.

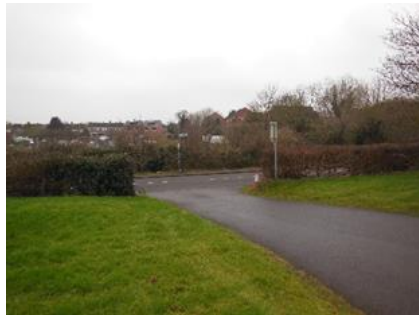
- b) The entrance from the car park onto Shottery Lane is relatively narrow and there is no pavement/footpath.

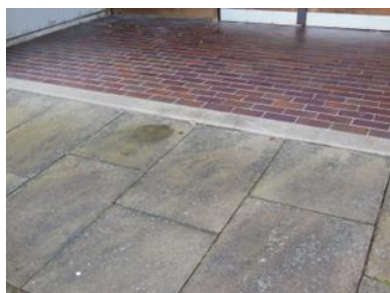
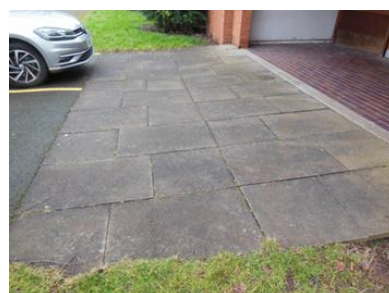
- d) The paving slabs leading up to the lobby entrance are uneven and could become a trip hazard at the threshold with the brick paviors.
